Clash Publish

AT602167MQ - MUON BARREL
CHAMBERS DETAILED, SECTOR 15

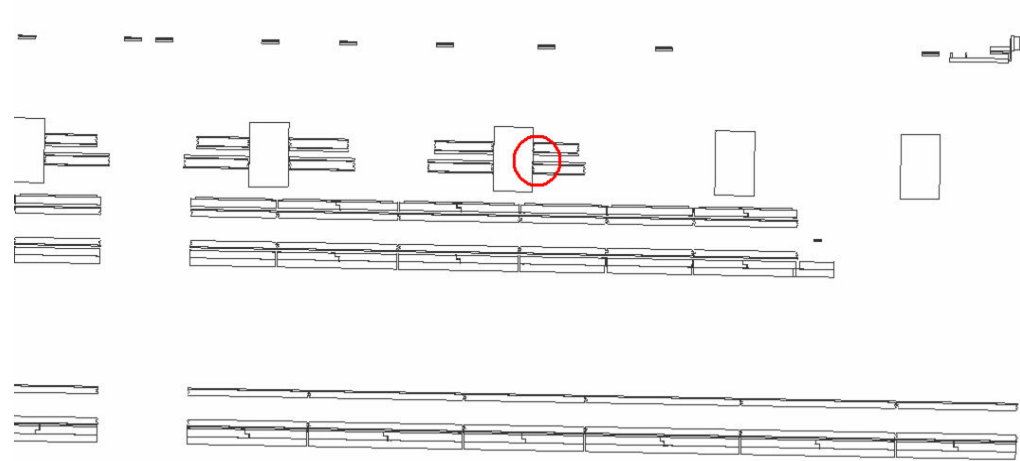
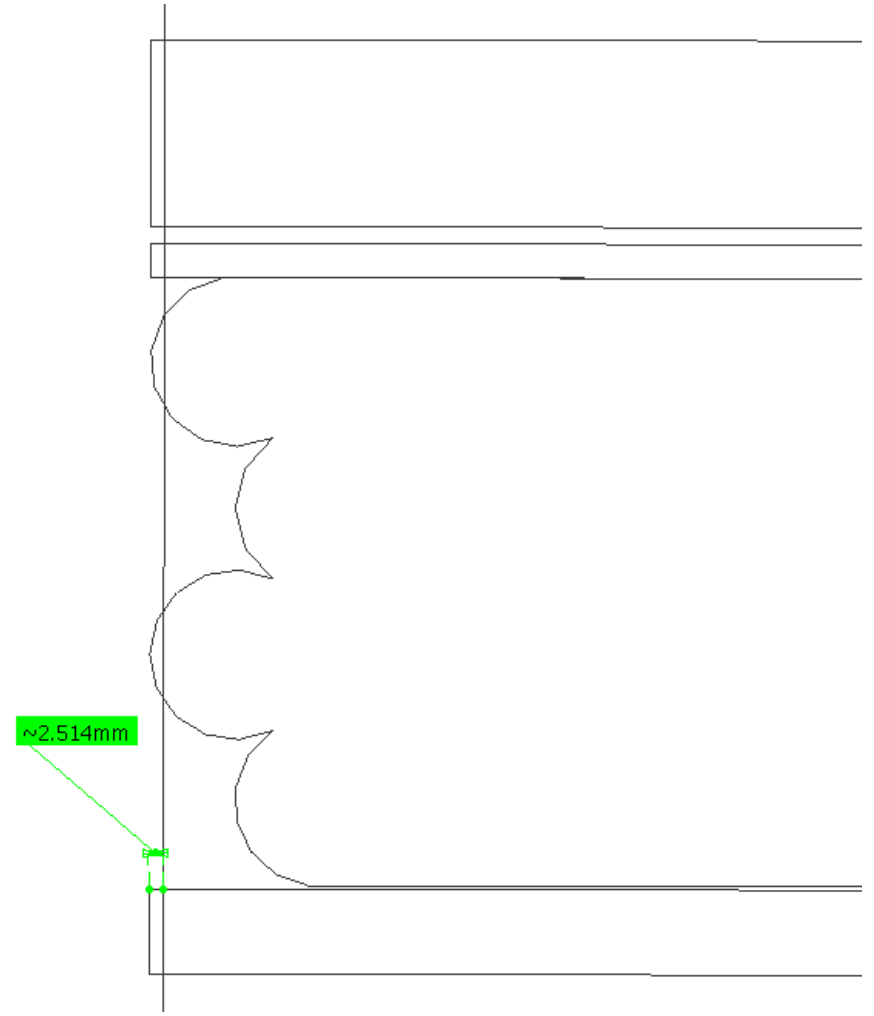
NTB_0007 - TB FEET COIL - SECTOR 14

-2.4 mm

Warning

Clash value: ~ 2.4 mm

SIDE A-C

Sector 15

The identical clash exists on the opposite side

Lasha: I have checked with VTB, cutout exists and there is no clash, however clearance is 22mm.

Tatiana: Check with VTB
